Manhole Inspection Summary

Manhole # S15II1010MH

Insp Date: **3/12/07 9:58 AM**

Location Address: **2418 LOYOLA NORTHWAY**

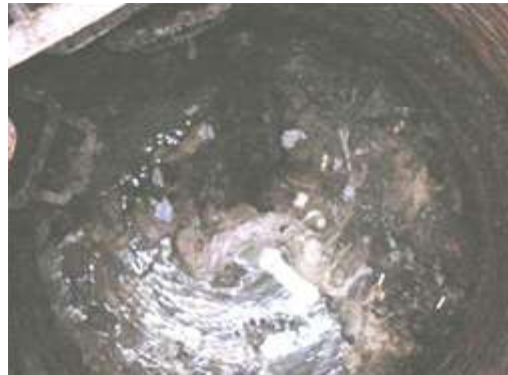
Top View

Corroded steps. Evidence of surcharge - Bench debris. Channel debris.

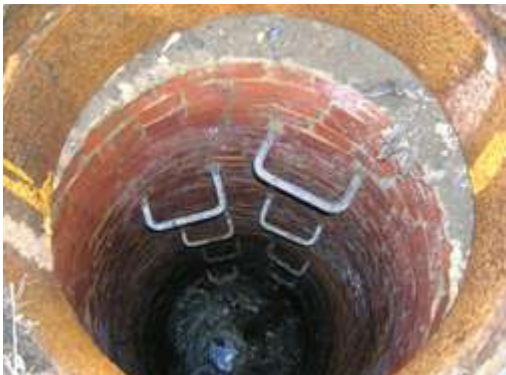
Defect

Frame offset. Adjustment and Corbel infiltration. Corroded steps. Evidence of surcharge.

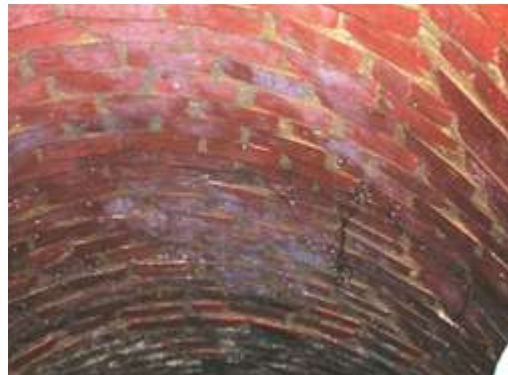
Defect

Barrel root intrusion and infiltration.

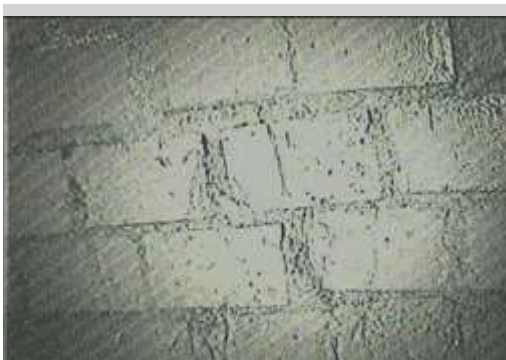
Defect

Corbel root intrusion and infiltration.

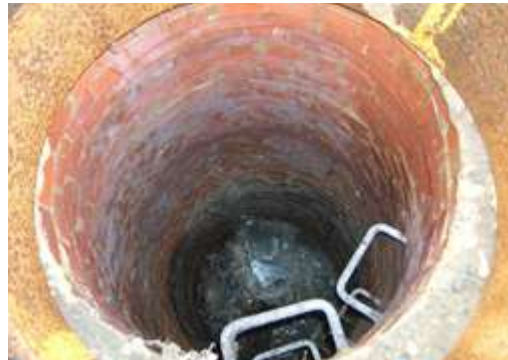
Defect

Frame offset. Adjustment root intrusion and infiltration. Corbel and Barrel infiltration - other side.

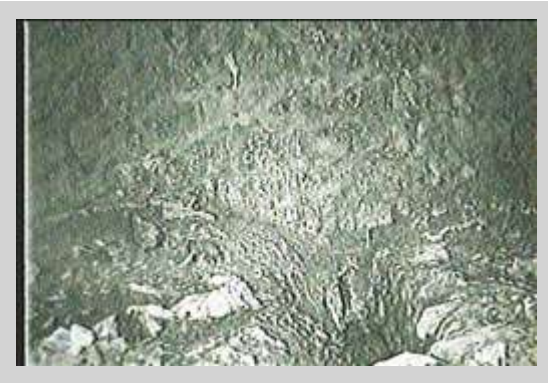
8 in. Circular Gravity Sewer Pipe Out @ 12 O'Clock

Barrel deterioration and infiltration.

Invert Depth: **14.31** (ft.) Flow Characteristics: **Slow**

Deposits: ☐ None ☐ Mud ☐ Sludge ☒ Debris ☒ Grease

Silt Depth: **1** (in.) Deposits Extent: **Light**

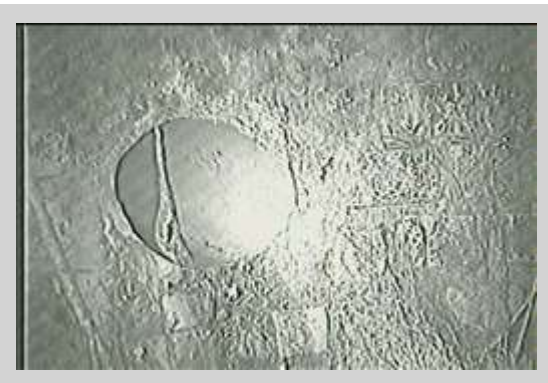
8 in. Circular Gravity Sewer Pipe In @ 5 O'Clock

Infiltration: **None** Pipe Seal Cond: **Roots**
